## The Practice of Detecting Termites with Infrared Thermal Imaging Compared to Conventional Techniques

*Mark Rentoul - Prime Building & Pest Consultants Pty Ltd*

### ABSTRACT

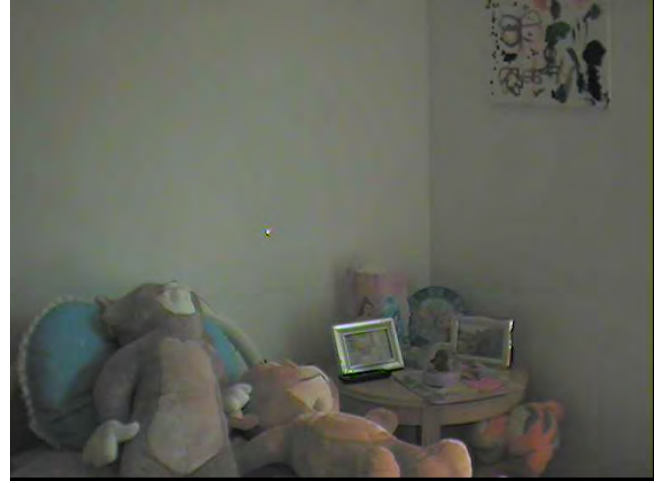
*Figure 3b. Visual image shows stored items*

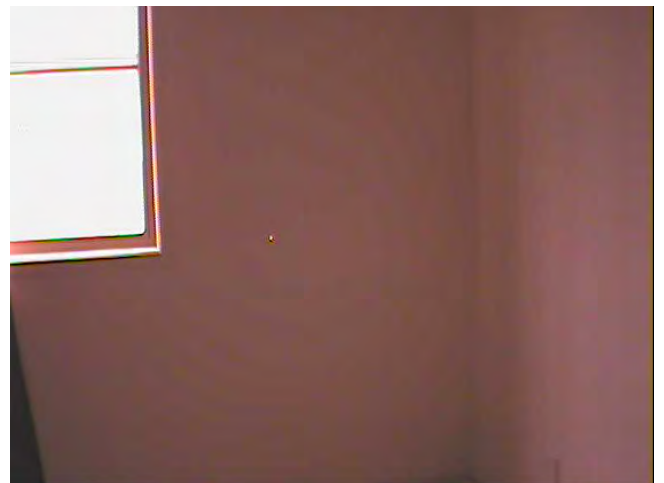
*Figure 4b. Visual image shows no signs of termites*
