**Ageing effect and long
term performance of
cement bonded
particleboard**

Prepared for: *Viroc Portugal –
Indústrias de Madeira e
Cimento S.A.*

Client report number 225399

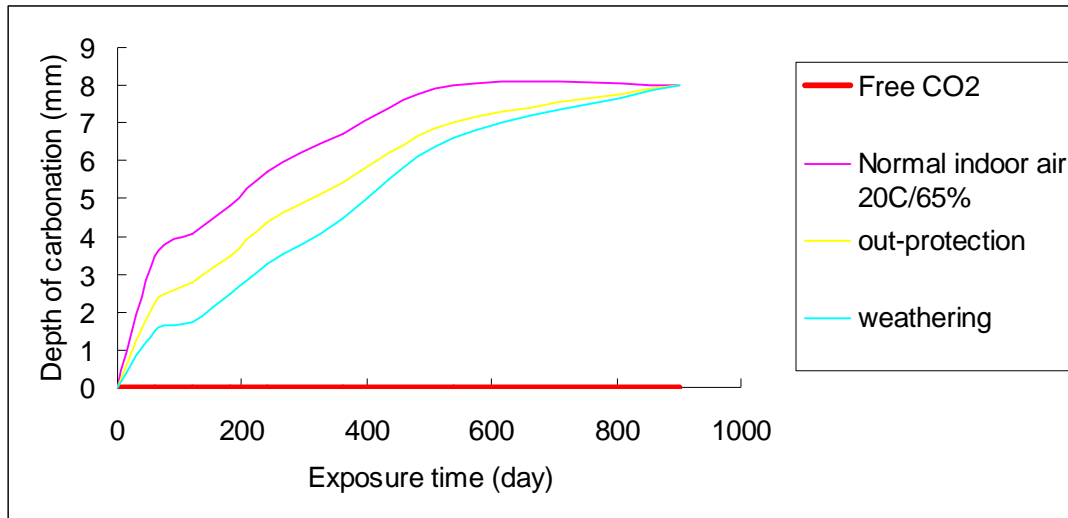
Figure 1 Mean depth of carbonation of Viroc CBPB with time under various exposure conditions

Figure 1 shows that the depth of carbonation of CBPB increased with the increase of time under various environmental conditions except for free CO₂ exposure. Substantial carbonation can occur even at the low CO₂ concentration normally found in the atmosphere. It is not limited to the hydroxide present, but is also associated with other components in CBPB. The resulting modification of the cement gel in CBPB is reflected in the changes in properties (see Tables 7 and 8). However, the most dramatic effect of carbonation of CBPB is a large increase in shrinkage under intermediate conditions, see next section.

The duration of carbonation for the CBPB tested was about 1.5 year (Figures 1 and 4)

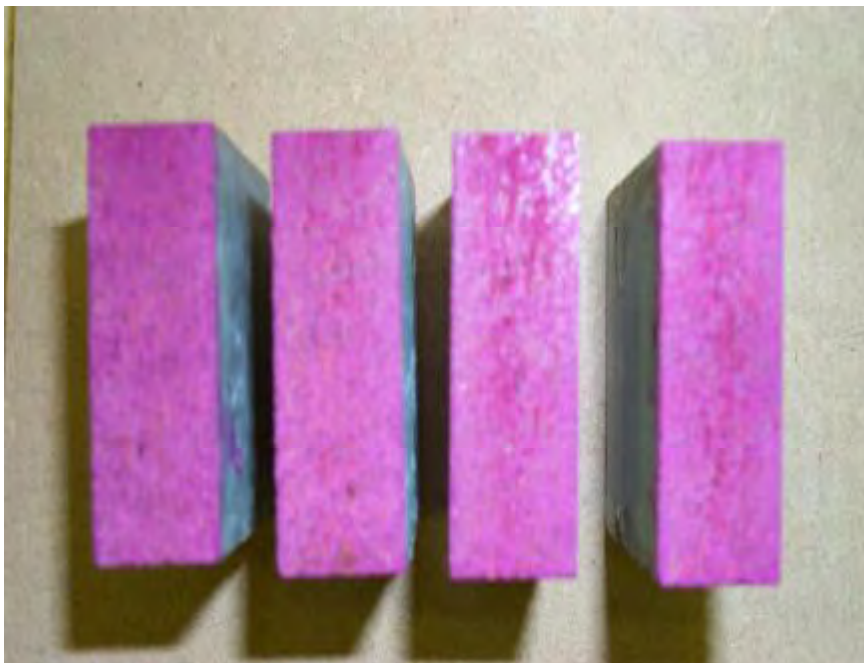
Figure 2 Fresh CBPB before exposure

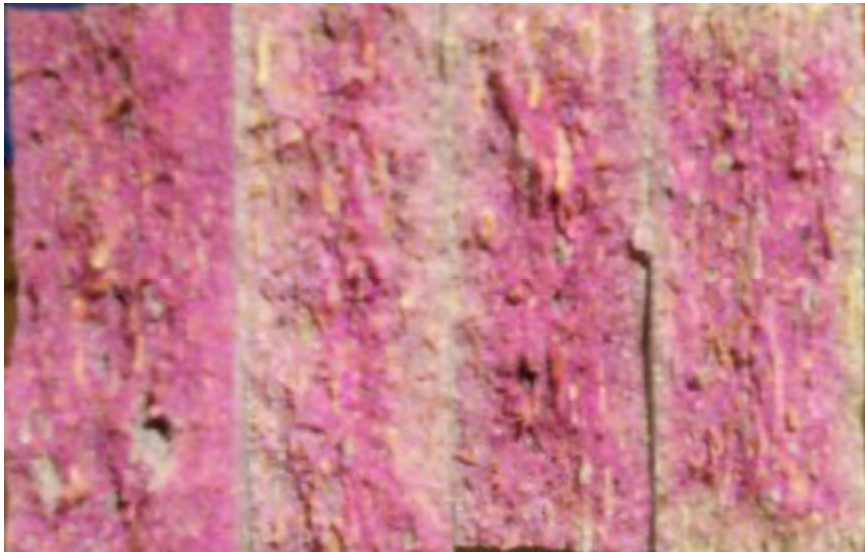
Figure 3 Carbonation of Viroc CBPB after 2 month exposure (from left to right: Free CO₂→normal air→outdoor protected→weathering exposure)

It can be seen from Figure 3 that the carbonation proceeded from 3-D. The rate of carbonation is more significant from the edges than from surfaces of the CBPB (Figure 3). There was no carbonation for CBPB under air devoid of CO₂.

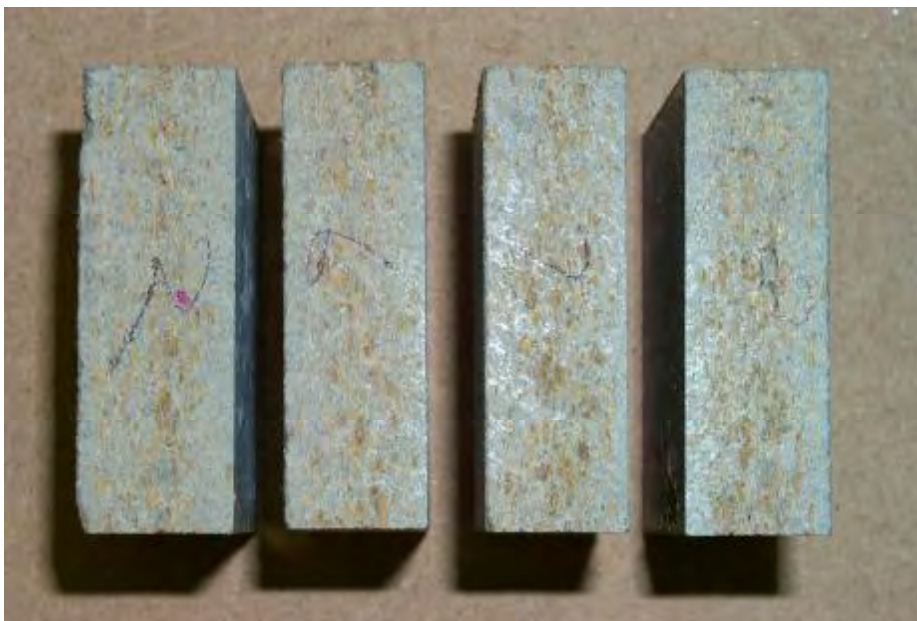
Figure 4 Fully carbonated Viroc CBPB after 2 year's exposure under normal indoor air environment

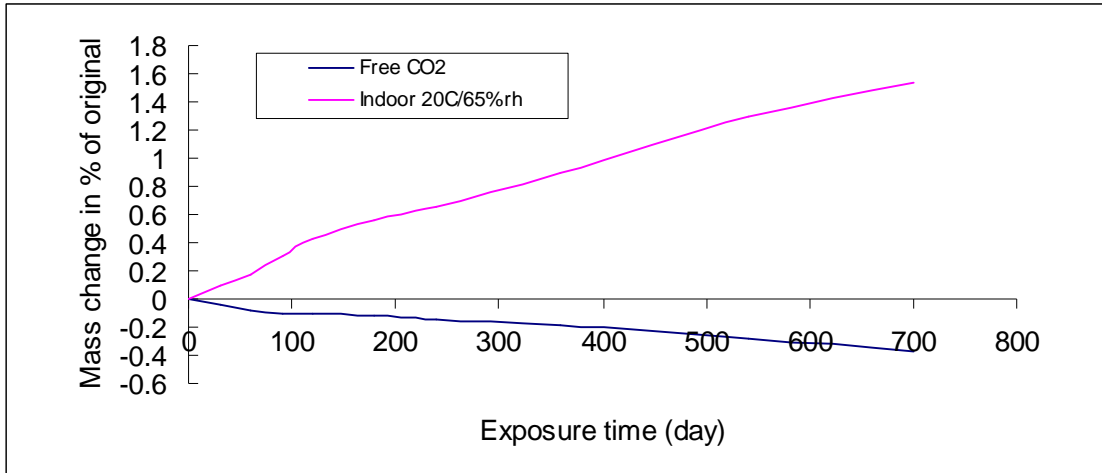
Figure 6 Average increase in mass of Viroc CBPB

In summary, mass of Viroc CBPB consistently increased and dimensions decreased under normal air exposure. It should be NOTED that these changes are irreversible.

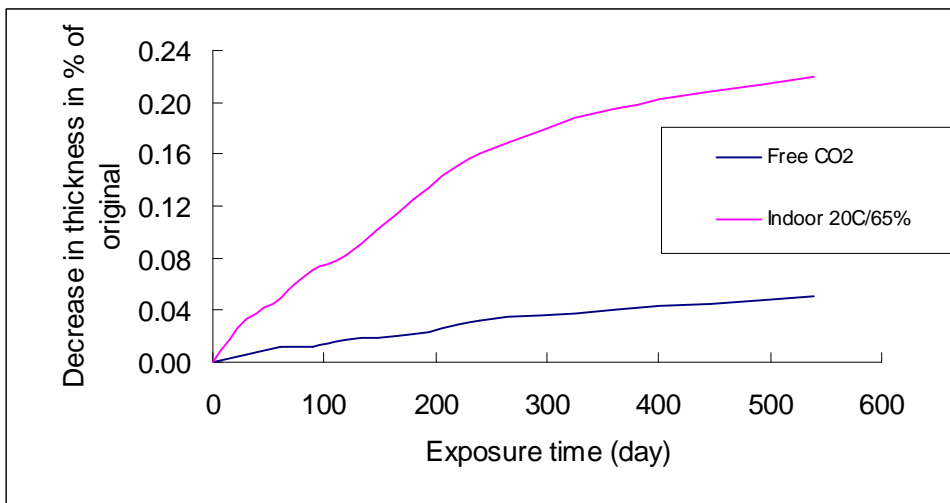
Figure 7 Average decrease in thickness of Viroc CBPB

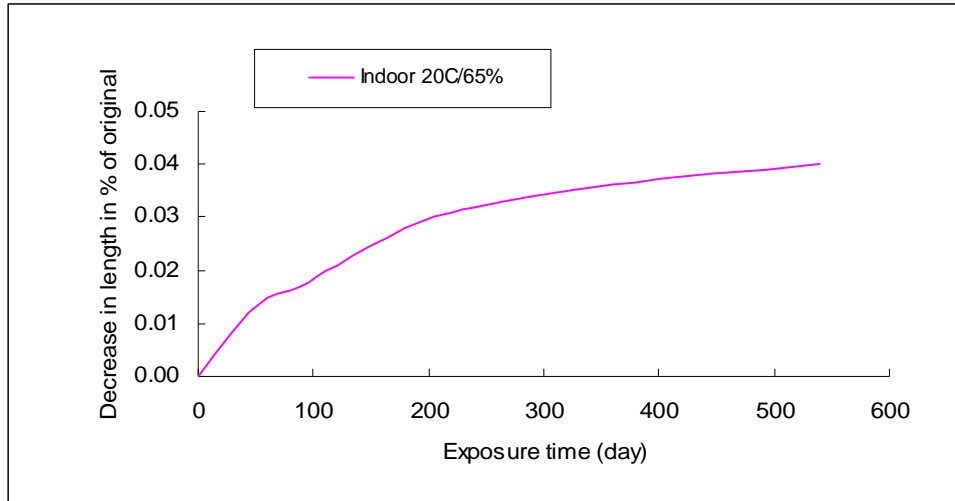
Figure 8 Average decrease in length of Viroc CBPB

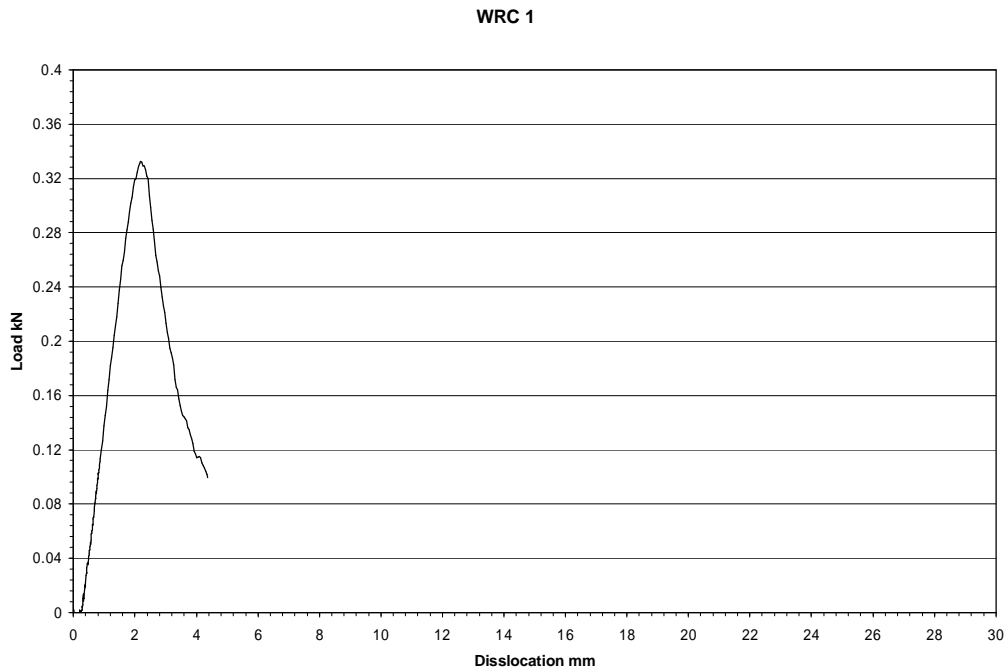
Figure B1 Stress-strain curve of Sample 123: Fmax=332.30N

The change in the strength and stiffness of Viroc CBPB was also examined under various exposure environments, that is, under normal indoor, under free CO₂, under outdoor protected and under weathering exposure. A summary of the results is given in Tables 9 and 10. Examples of the stress and strain are plotted and given in Appendix B.

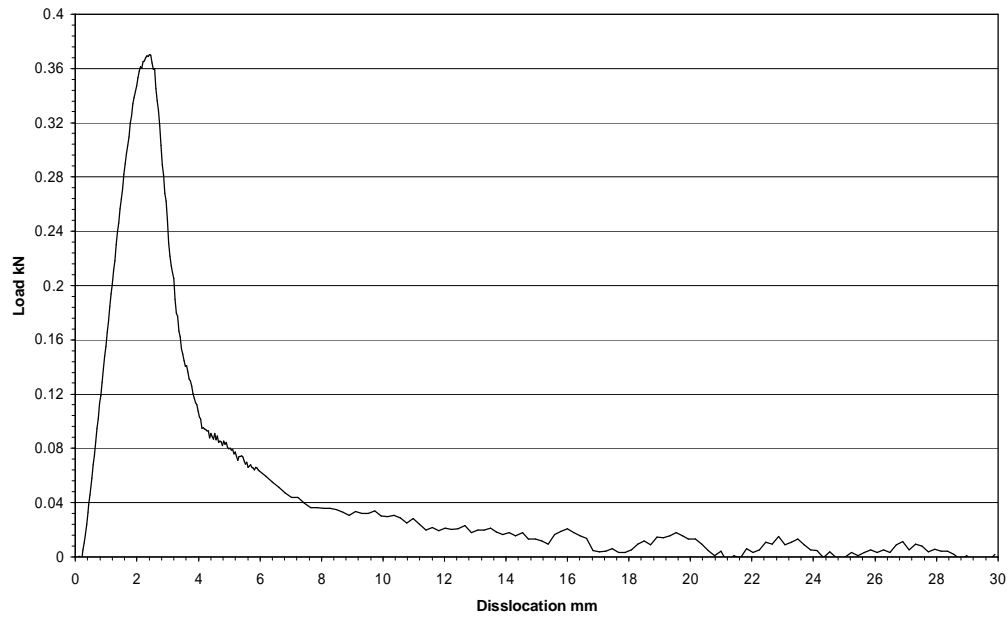
Figure B2 Stress-strain curve of Sample 135: Fmax=370.29N

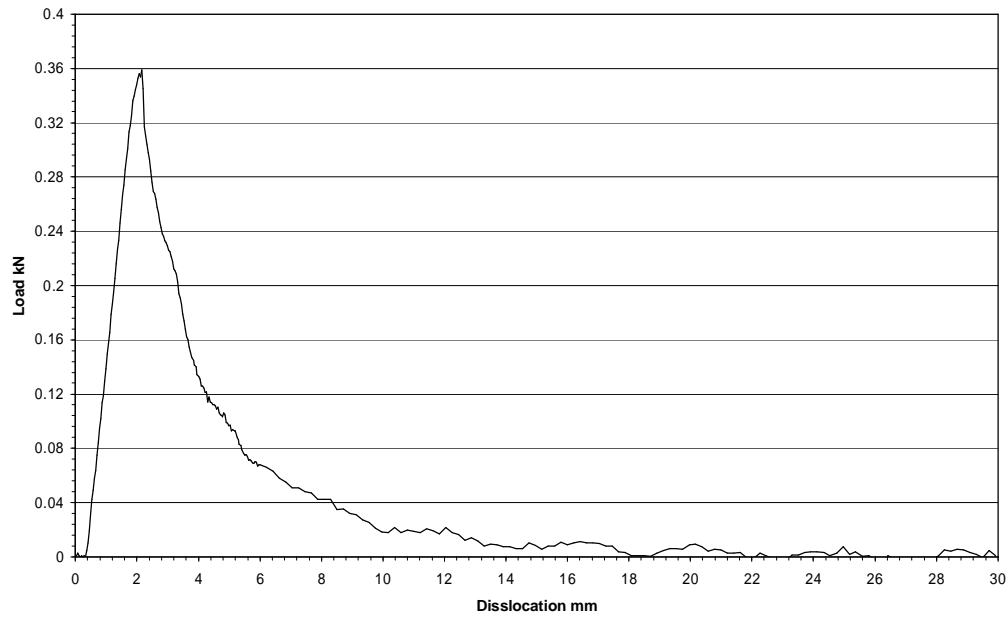
Figure B3 Stress-strain curve of Sample 147: Fmax=358.83N

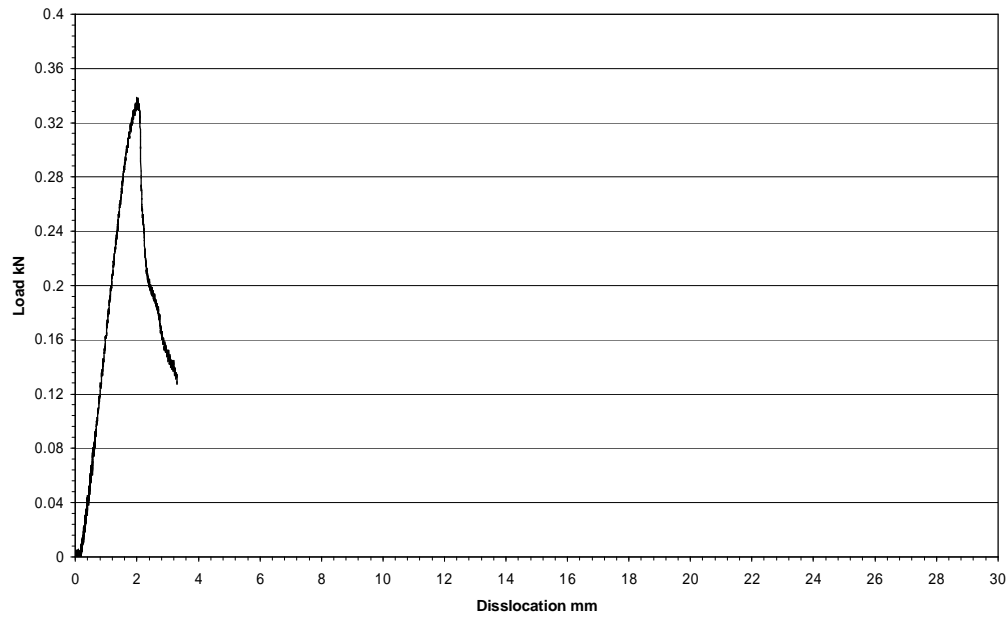
Figure B4 Stress-strain curve of Sample 189: Fmax=338.61N
